Poor workmanship does more than fail to meet Regulation 7 – it puts lives at risk.

Ciara Holland, Martin Shipp and Dr David Crowder of BRE Global make the case.

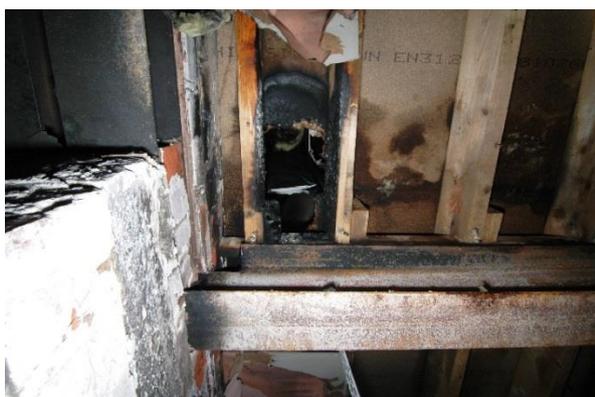
A fire was discovered in a basement car park of a block of flats with four accommodation storeys above at around 04:00. The cause of the fire was undetermined but fully involved two cars. Smoke and flames from the fire spread to the upper floors of the building due to poor fire stopping of penetrations in the concrete slab between the car park and the upper floors (Figure 1). The fire burned through the floor above, via a poorly fire-stopped soil pipe, into a bedroom of one of the flats where the bed caught fire with the resident asleep in it. The inadequacy of the fire stopping was attributed to poor workmanship as some fire stopping around penetrations was effective. Three people suffered smoke inhalation and one sustained a broken ankle. Ten other people were rescued by the Fire and Rescue Service.

Figure 1 – Hole burned through floorboards between the car park and block of flats above

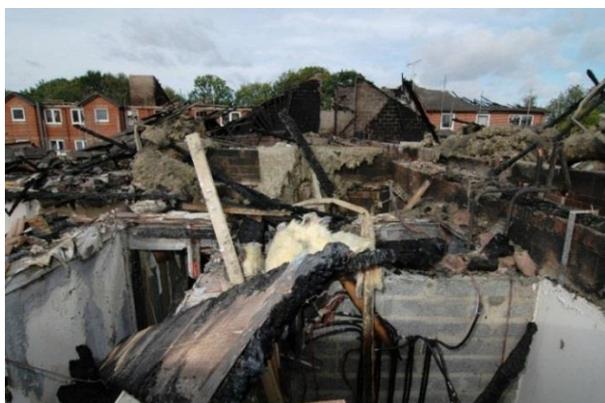
A fire started in a first floor flat of a two- and three-storey block due to a fault in a television. The fire spread from the flat of fire origin out of a window and entered the roof void above via the eaves. Once in the roof void, the fire spread unhindered due to inadequate cavity barriers used for compartmentation, this being attributed to poor workmanship. Figure 2 shows the extent of damage to the roof. Due to the lightweight construction of the roof timbers, collapse of the roof structure occurred early on in the incident which forced withdrawal of fire crews before they could complete rescue operations. One elderly female resident died in the bedroom of a flat located two doors along from the flat of fire origin. It is understood the woman suffered from some degree of mobility impairment, which was typical of the residents in the property. An undetermined number of other residents were understood to have become trapped in their flats and required rescue by the Fire and Rescue Service.

Figure 2 – Extent of damage to roof structure

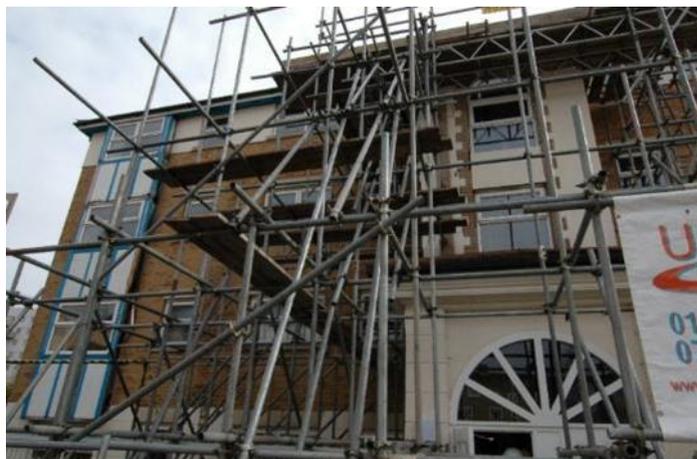
A fire in a four-storey purpose-built block of flats was discovered at around 00:38. The building comprised four flats on each floor and was constructed in the 1990s from timber frame with predominantly brick cladding. The fire started in a cavity wall on the ground floor, spreading horizontally and then vertically upwards to the second and third floors and into the roof space where it burned through part of the roof. Cavity barriers were in place horizontally between floors; however, the oriel window detail at the front of the property (Figure 3) did not have any cavity barriers either vertically or horizontally. These missing cavity barriers created a route for fire spread up the building. There were no reported injuries but 33 residents were evacuated as a precaution. The cause of the fire is understood to have been due to an electrical cable arcing on a plasterboard fixing in the wall cavity.

Figure 3 – Front elevation of block of flats. The building façade was left unstable as a result of the fire
