## **Fire compartmentation in roof voids**

By Martin Shipp, Ciara Holland, David Crowder and Tom Lennon

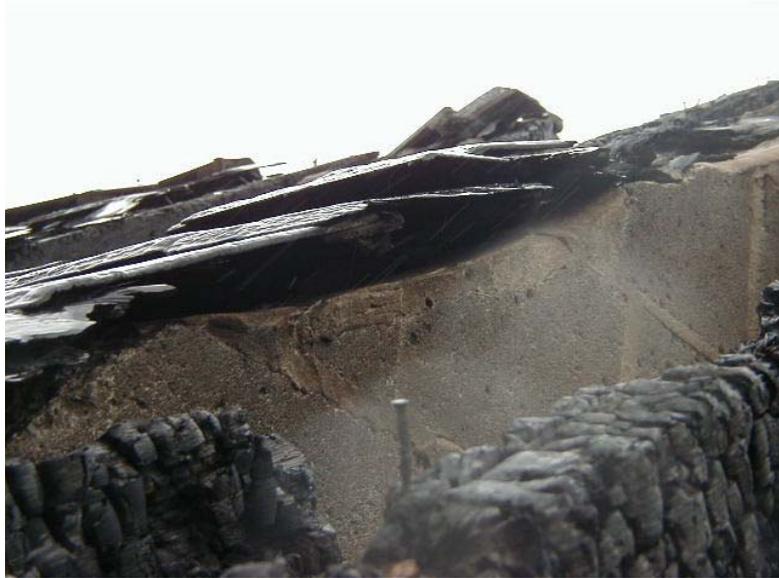
The fire started in a small section of a flat roof of one apartment block, ignited the sarking felt on the adjacent pitched roof and spread into the roof void. The fire spread within the roof space over three apartments, bypassing two compartment walls. Eventually, the fire spread into the roof void of an adjacent block, again involving three apartments and bypassing two compartment walls. The compartment walls were constructed from concrete building blocks. However, it was clear from the scene that no attempt had been made to fire-stop the junction between the walls and the roof as detailed in Approved Document B [2]. Figure 1 shows the junction of the compartment wall with the roof covering.

**Figure 1 – Lack of fire stopping between compartment wall and roof covering**

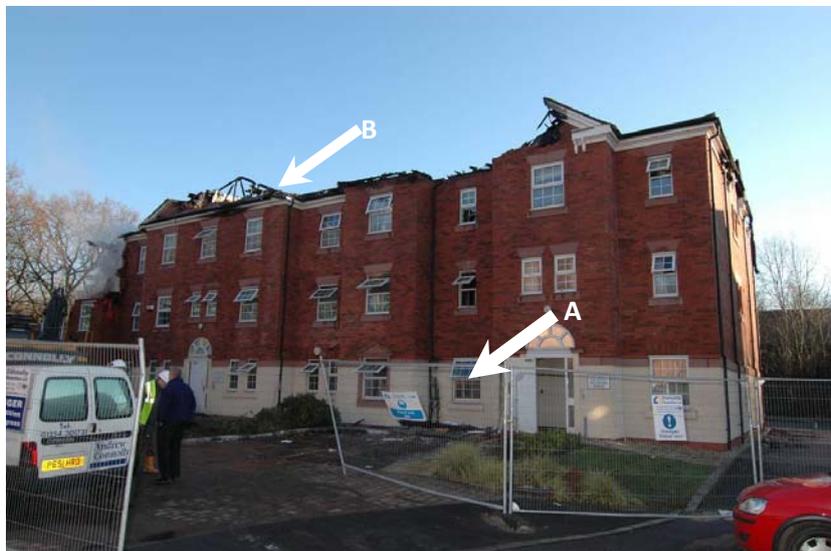
It is likely that the fire was initiated as a result of hot work being carried out on pipes penetrating the exterior wall of the three-storey block of flats. Initial fire spread was through the external wall cavity breaking out at roof level some distance from the point of origin. Once in the roof area, the fire spread rapidly, leading to collapse of the roof trusses and break out back into the floors below. It is clear from the speed and extent of the fire spread that the cavity barriers in the wall and compartmentation within the roof space were ineffective. Figure 2 shows the point of fire origin and the area where the fire broke out from the roof.

**Figure 2 – Block of flats showing the area of fire origin and damage to roof level. Arrow A indicates point of fire origin. Arrow B indicates point of break out at roof level**

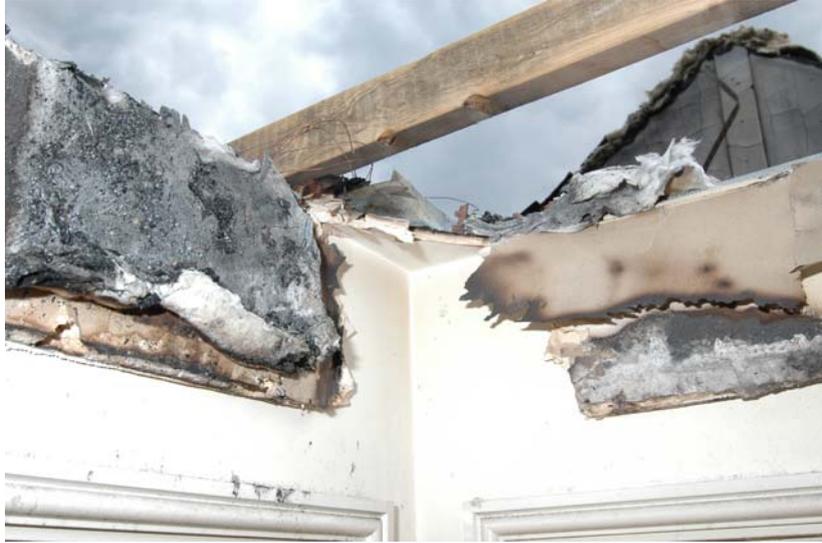
coat. The walls were continued up through the ceiling to the underside of the roof covering. The seal between the top of the wall and the roof covering seems to have been made from mineral wool (see 4). It is believed that the fire spread due to a combustible membrane between the tiles and the roof structure (see Figure 4).

**Figure 3 – Mineral wool fire-stopping along pitch of roof in the background of the photograph**

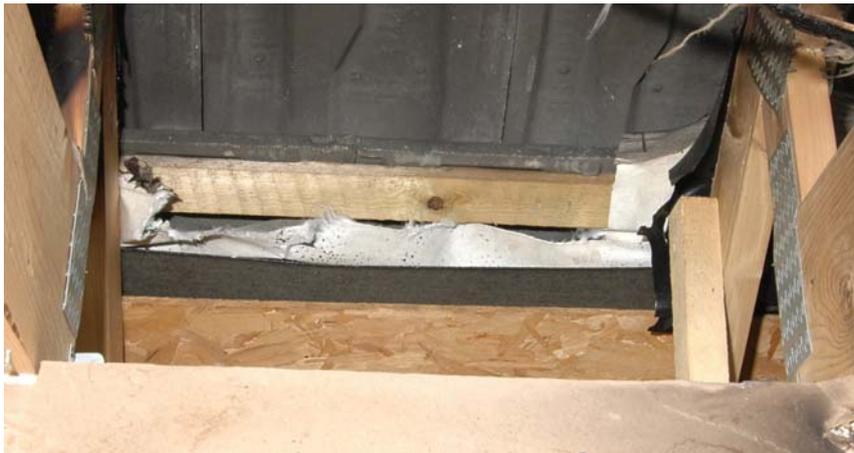
**Figure 4 – Combustible membrane under roof covering**

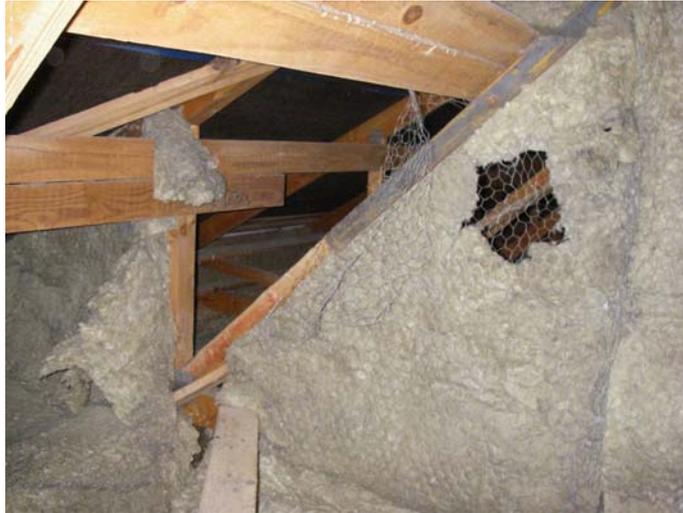
Fire broke out in one of the flats on the top floor of a four-storey apartment block. The fire broke out of the window and into the roof void through the roof eaves soffit and spread to destroy the entire roof area. The roof was a new pitched roof over an existing flat roof formed from a concrete slab. For this reason, the roof void could be considered to be a single compartment and separation would be necessary to maintain the maximum distances of cavities rather than specifically to maintain compartmentation. Separation was provided in the roof space at approximately 15m intervals, comprising mineral wool and chicken wire curtains held in place with metal bars fixed to the timber trusses. The separation in the roof space clearly did not perform as intended. The poor state of the compartmentation in the roof space had been highlighted in a previous report following a fire on the same estate. The condition of the fire stopping in the roof space in a similar block is illustrated in Figure 5.

**Figure 5 – Fire stopping in poor condition (Image courtesy of London Fire Brigade)**

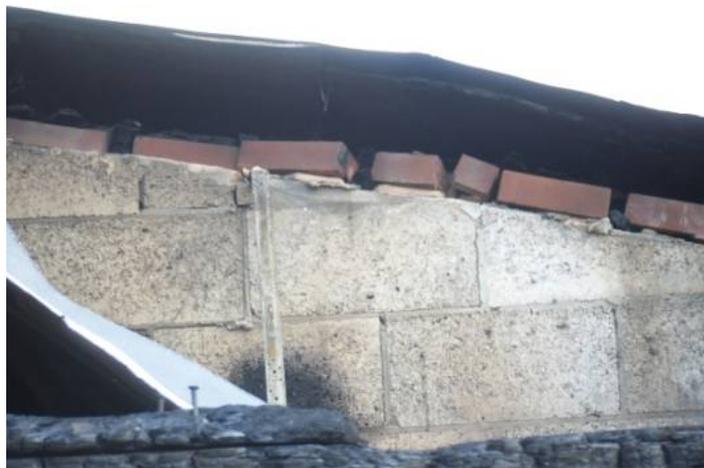
The fire occurred in a flat on the top floor of a three-storey block of flats and spread into the roof space. The fire developed to involve the roof space over all three flats on the top floor. Fire spread over the compartment walls in the roof area appears to have been due to a combination of poor fire stopping in the compartment walls above ceiling level, poor fire stopping where the curved sections of the roof crossed the compartment walls, and fire bridging the compartment walls due to the presence of combustible materials within the make-up of the roof covering. Figure 6 shows the attempt made to provide fire stopping where the curved section of the roof crossed the compartment wall.

**Figure 6 – Attempt to follow roof profile over compartment wall**

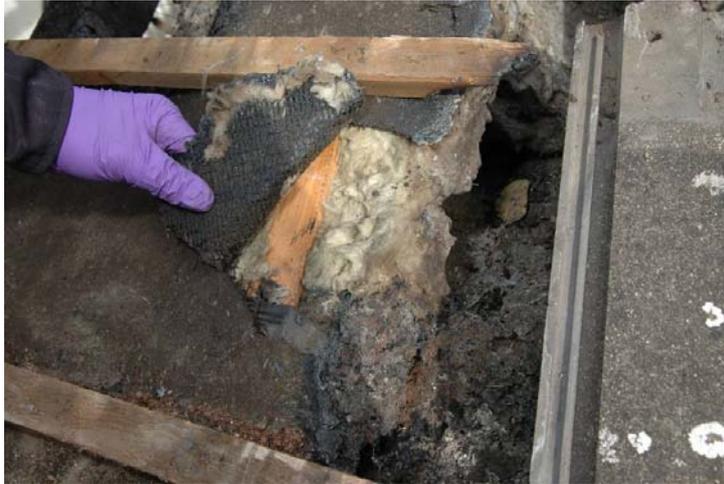
The fire started in a first floor flat of a block of flats, broke out of the room of origin through a window, and entered the roof through the eaves. Fire spread rapidly throughout the structure of the roof. The roof was constructed from lightweight timber truss rafters. The roof covering was ceramic tiles under which a bitumen impregnated sarking felt had been fixed. Fire separation within the roof space was completed using a mixture of blockwork and cavity barriers. The cavity barriers were constructed from mineral wool fixed to a wire mesh. The barriers were fixed to timber trusses using clamping plates. The fixing of the fire barrier to the timber trusses does not appear to have been in accordance with manufacturer's guidance since the barriers did not press up against the underside of the sarking

felt so the fire was able to spread along the sarking felt over the top of the cavity barriers (see Figure 8).

**Figure 7- Fire stopping against underside of sarking felt but not pushed up against underside of roof tiles**

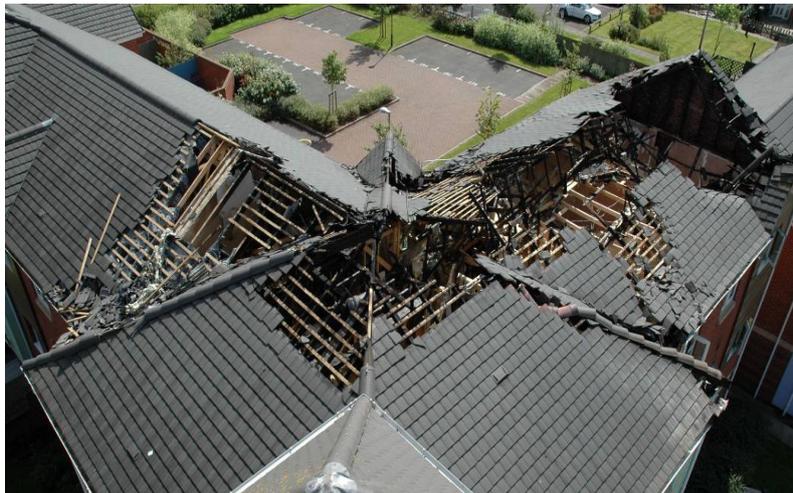
The fire is believed to have been started by a cigarette discarded in wood chippings in flower beds arranged around the outside of a three-storey block of flats and in contact with the external wall. The fire spread from the wood chippings into the cavity of the external wall via a plastic air brick providing ventilation to the cavity situated beneath the suspended ground floor. Cavity barriers in the external wall cavity were either missing or poorly fitted. The fire spread up the cavity to the roof of the building, causing significant structural damage to the roof and accommodation storeys. A combination of fire-fighting and effective compartmentation, both between compartments and within the roof space, prevented more extensive fire spread within the building. Figure 8 is an aerial view of the building showing the damage at roof level.

**Figure 8 – Aerial view showing damage to roof structure**

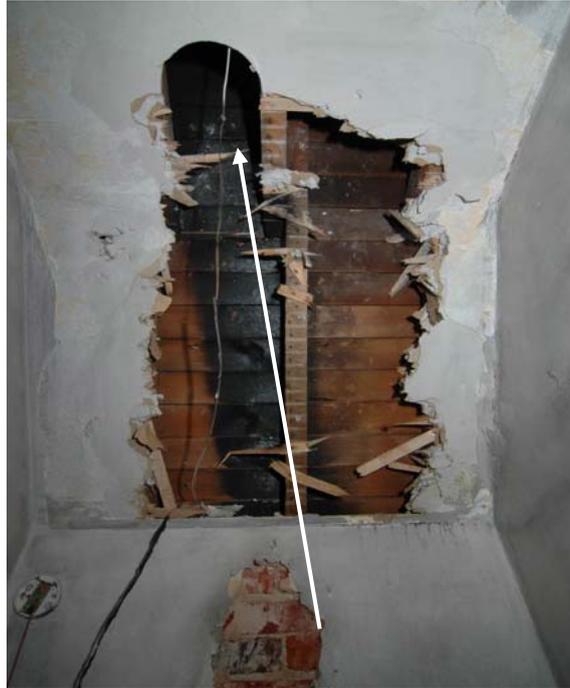
void. However, there was inadequate separation within the roof space. The junction between the external wall cavity and the roof space is shown in Figure 9.

**Figure 9 – Close up of fire damage to pitch roof (arrow showing direction of fire spread from wall cavity)**

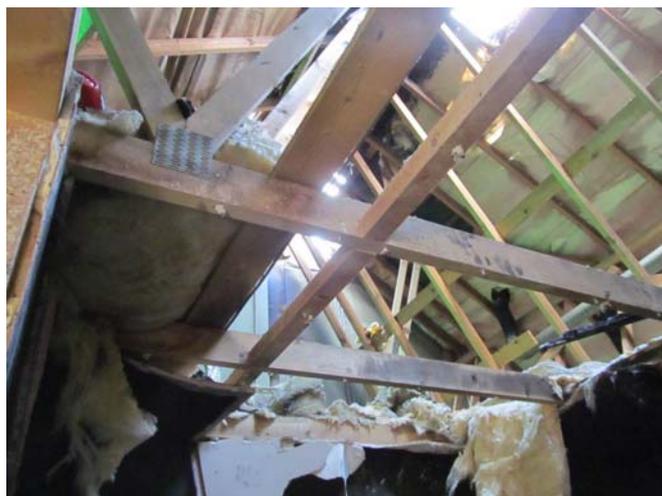
The fire was started within an upper floor bedroom of a three-storey timber-frame terraced house and flames spread into an external wall cavity through failure of a uPVC window frame. From there, it spread into a compartment wall separating dwellings. In this case, the quality of the compartmentation in the roof space prevented more widespread damage as can be seen from the undamaged roof trusses in Figure 10. The compartmentation was formed from two layers of plasterboard either side of the timber frame compartment wall, with all joints fully taped and sealed.

**Figure 10 – Undamaged roof trusses above seat of fire**

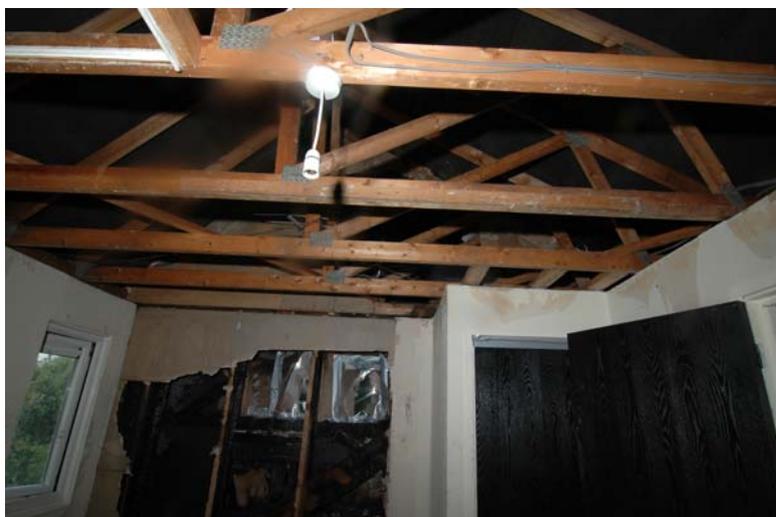
The fire started within a ground floor flat and spread via the external façade into the compartment wall between occupancies. As with the incident in Case 9, the quality of compartmentation in the roof space, as shown in Figure 11, restricted the amount of damage from the fire.

**Figure 11 – Top floor of property showing fire damage in party wall but roof trusses are unaffected by the fire due to compartmentation**
