# Fire safety issues with balconies

By Ciara Holland, Martin Shipp and David Crowder of BRE Global

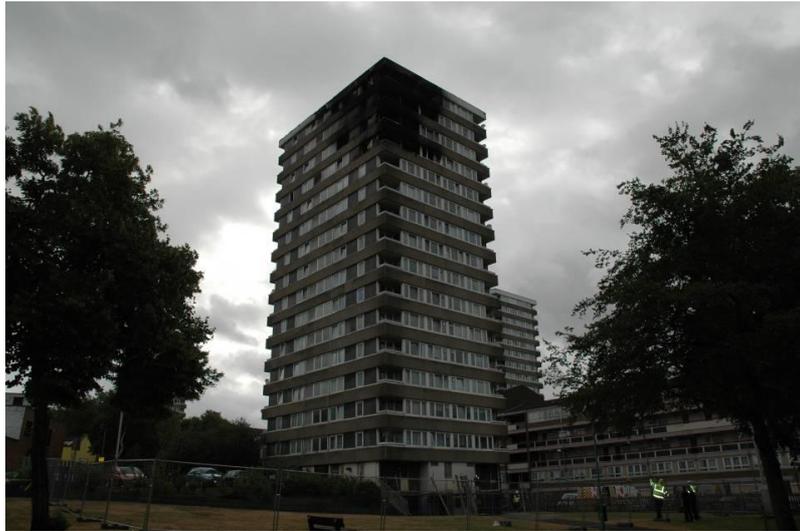
A deliberate fire was started on the balcony of a 12<sup>th</sup> floor flat of a 16-storey residential block of flats constructed in the 1960s. As can be seen from Figure 1, the fire spread from the balcony of origin to the 15<sup>th</sup> floor and the roof of the building. Several features of the building were attributed to the extent of fire spread including combustible insulating panels (which were clad onto the underside of all of the balconies), cladding panels (which had been installed onto the outer surface of the exterior wall and comprised a mineral fibre board face supported on timber battens, behind which there was a fibrous combustible insulation material) and plastic drain pipes (which were installed at each corner of the building and passed through the concrete floor slab on each floor). There was no evidence of any fire stopping, proprietary seal or sleeve where the pipe passed through the floor slab in the balcony which should have been provided to maintain the level of fire resistance afforded by the concrete floor slab.

**Figure 1 – Block of flats showing extent of fire damage caused by holes in compartmentation on balconies**

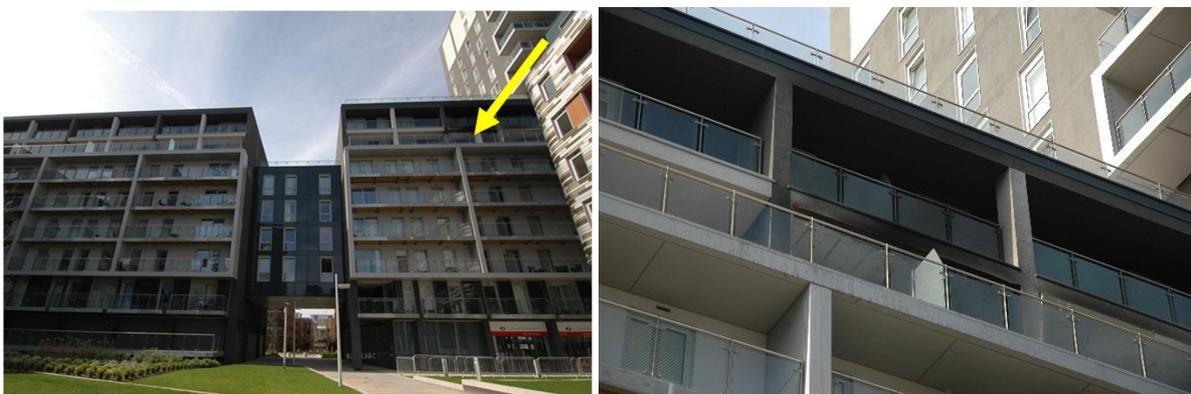
A fire started on a balcony on the sixth floor of an eight and 16-storey purpose built block of flats constructed circa 2009 (Figure 2). The fire was caused by misuse of smoking materials; a plastic cup had been used as an ashtray and the lit cigarette had ignited the balcony components. The block was predominately of concrete construction with external surfaces covered in a variety of cladding systems, with cavities filled with a variety of rigid foam insulation. The construction detail of the balconies in the development seemed to vary; the balcony of fire origin appeared to be supported on an extension of the concrete floor slab of the main building structure but other balconies were timber built into the structure. The floor of the balcony was covered with timber decking on timber battens supported on polyethylene spacer rings. The spacer rings were, in turn, situated on a layer of foam insulation covered with a woven plastic sheet. It is this plastic sheet which is understood to have ignited and this, in turn, ignited the foam insulation under the decking. The fire spread under the decking consuming the foam insulation and also spread to involve insulation behind cladding systems on external walls. The fire also involved the ceiling of the balcony which had an expanded polystyrene insulation behind a render. The fire spread to the balcony of the neighbouring flat on the same level under the decking. There were no reported injuries as a result of the incident.

**Figure 2 – Extent of damage to balcony, left, indicated by arrow and close-up view, right**
