## **Learning lessons from the Edinburgh Schools inquiry**

### **As well as putting lives at risk, hidden defects in passive fire protection are leaving schools open to unplanned disruption or even closure.**

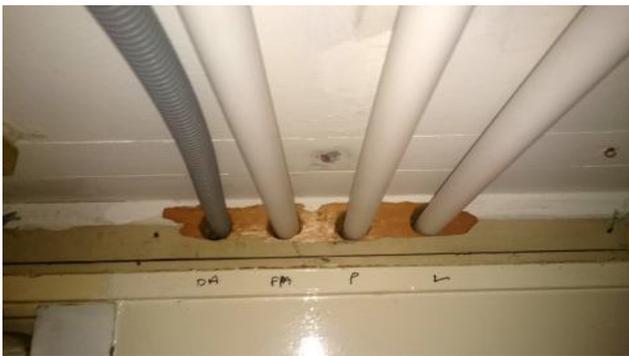
(Img 2): Retrofitted services pushed through a fire rated door frame, rendering the existing fire rating ineffective.

Other commonly cited issues relate to the modernisation of services which can leave walls, ceilings and floors peppered with holes in order to route new electrical/IT cabling, or mechanical upgrades. All too often, such modifications are implemented with little understanding of the fire strategy objectives for the building or without adequate attention to fire-stopping.

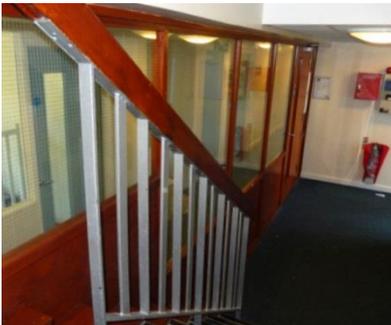
(Img 3): Old style Georgian wire glass partition being used to protect escape staircase. Favoured in the past for its physical integrity, this type of glass provides little barrier to flame radiation and can allow fire to quickly penetrate.

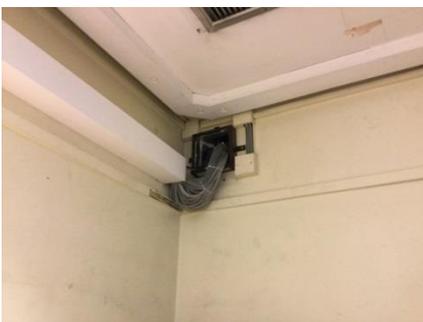
(Img 4): Inadequate fire-stopping of service penetrations is a prevalent defect observed during inspections of passive fire protection.

A large proportion of fire-stopping defects lurk above false ceilings and in areas that are out of sight and difficult to access. It means that many potential weaknesses and gaps in passive fire protection will not be spotted even during a routine fire risk assessment.
