## External fire spread: new research

**In a two-part feature, BRE Global reports on the latest findings to come out of its work on the ‘Investigation of Real Fires’ for the Department for Communities and Local Government (DCLG)**

By Ciara Holland, Dr David Crowder and Martin Shipp

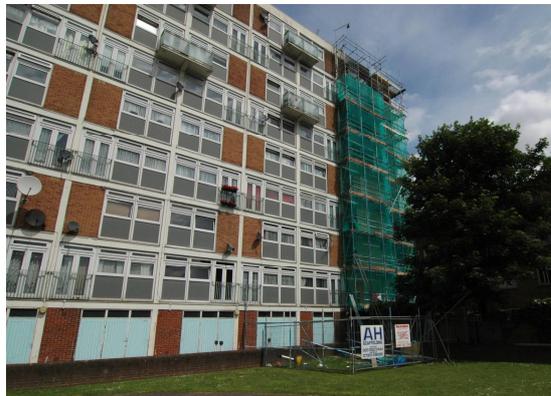
A fire occurred in a first floor flat of a 1960s nine-storey block of maisonettes. The external walls of the flats incorporated uPVC window and door units (Figure 1) and some of the lower window panels had been replaced with painted metal panels (comprising two sheets of painted metal, possibly aluminium, and a thin layer of adhesive holding the two together). The fire melted the frames of the window units, allowing flames to extend up the building exterior. These flames were sufficient to melt the frames and break the window panes of the floors/flats above the flat of fire origin, causing fire and smoke damage within the flats from the third to the sixth floors.

**Figure 1 – Block of flats showing undamaged window sets; the fire damage is behind the scaffolding**

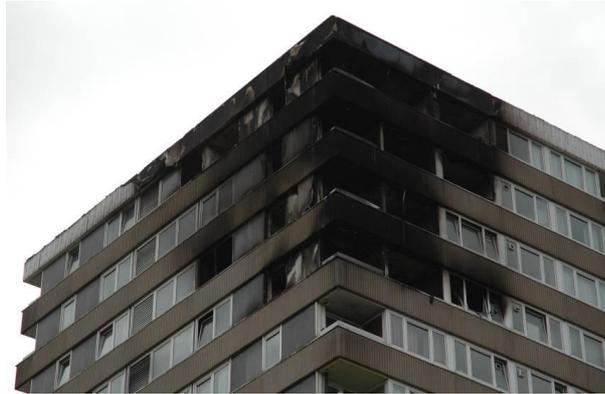
A fire started on the balcony of a 12<sup>th</sup> floor flat of a 16-storey residential block of flats constructed in the 1960s. As can be seen in Figure 2, the fire spread from the balcony of origin to the 15<sup>th</sup> floor and the roof of the building. Several building features were attributed to the extent of fire spread including:

- combustible insulating panels clad onto the underside of all of the balconies;
- cladding panels installed on the outer surface of the exterior wall, comprising a mineral fibre board face supported on timber batons in front of a fibrous combustible insulation material;
- plastic drain pipes installed at each corner of the building, passing through the concrete floor slab on each floor.

There was no evidence of any fire stopping, proprietary seal or sleeve where the pipe passed through the floor slab, which should have been provided to maintain the level of fire resistance afforded by the concrete floor slab.

**Figure 2 – Block of flats showing extent of fire damage caused by holes in compartmentation on balconies**

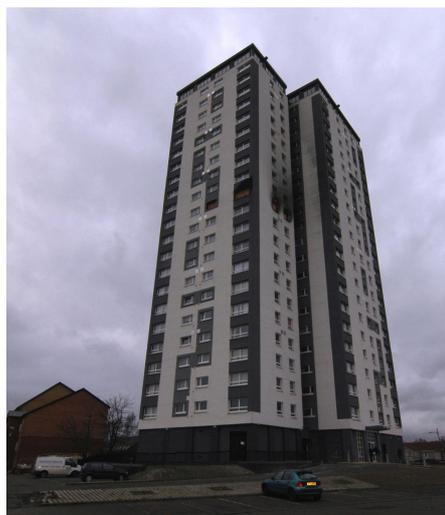
A fire occurred in a flat on the 11<sup>th</sup> floor of a 22-storey block of flats built during the 1960s and refurbished in 2006/7. This refurbishment included the fitting of a new cladding system to the exterior of the building comprising an insulated render containing mineral wool insulation, which had been tested to and passed BS 8414-1. The fire developed to fully involve the flat of origin and broke out of the windows. Façade damage was localised to the immediate vicinity of some of the windows, and beyond this, appeared to have been limited to surface charring and sooting (Figure 3).

**Figure 3 – Block of flats showing limited damage to the non-combustible cladding system after a fire**
